# Manhole Inspection Summary

Manhole # S39MM\_015MH

Insp Date: **3/1/07 1:21 PM**

**Location** Address: **1900 CECIL AVE**

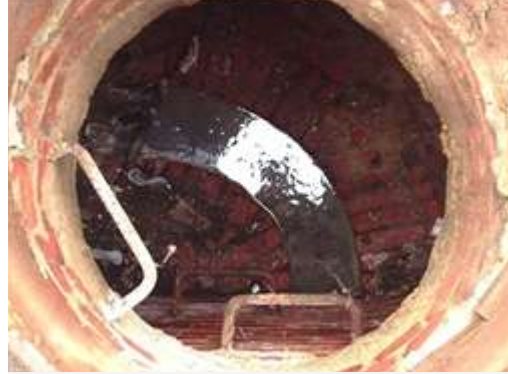
Top View

Corroded steps. Evidence of surcharge - Bench debris. Channel debris.

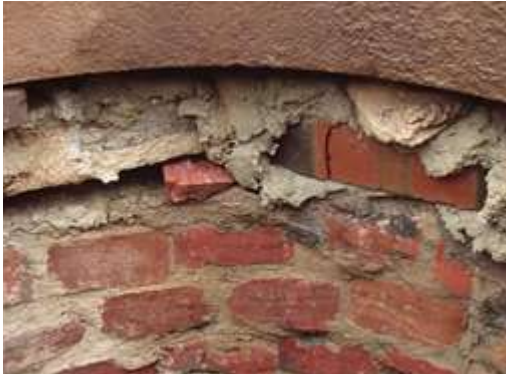
Defect

Frame leaks. Adjustment deterioration and infiltration.

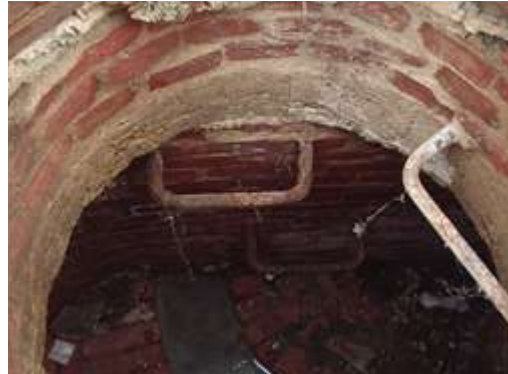
Defect

Frame leaks. Adjustment deterioration and infiltration. Barrel infiltration.

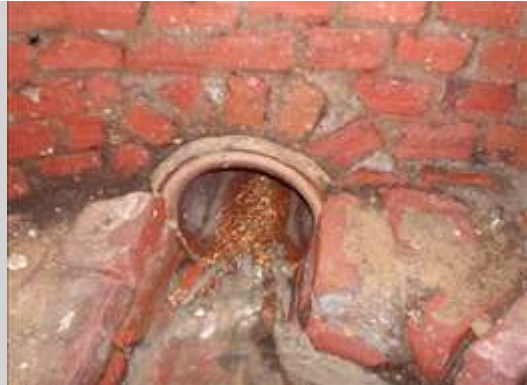
### 8 in. Circular Gravity Sewer Pipe Out @ 12 O'Clock

Deposits: ☐ None ☐ **Mud** ☐ Sludge ☒ **Debris** ☒ **Grease**

Silt Depth: **0** (in.) Deposits Extent: **Light**

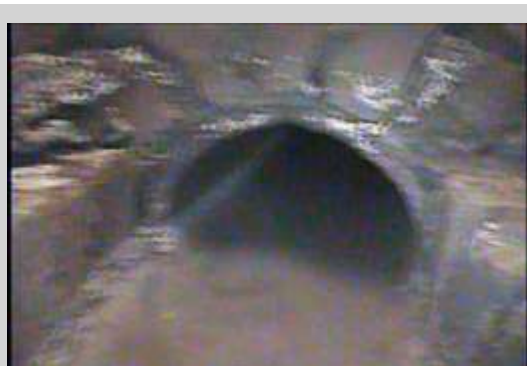
### 8 in. Circular Gravity Sewer Pipe In @ 6 O'Clock

Deposits: ☐ None ☐ **Mud** ☐ Sludge ☐ **Debris** ☒ **Grease**

Silt Depth: **0** (in.) Deposits Extent: **Light**

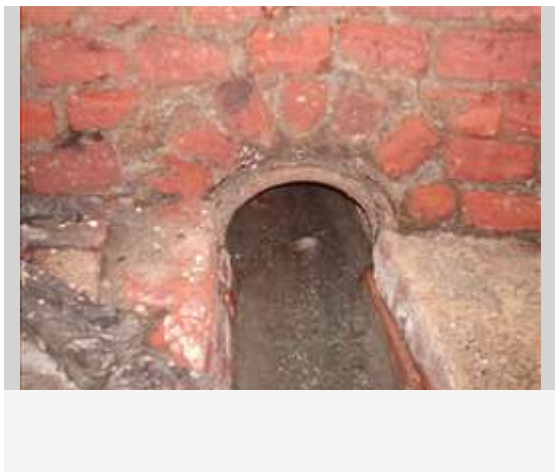
6 in. Circular Gravity Sewer  
Pipe In @ 7 O'Clock

Deposits: ☐ None ☒ **Mud** ☐ Sludge ☒ **Debris** ☐ Grease

Silt Depth: **1** (in.) Deposits Extent: **Light**

Infiltration: **Evidence** Pipe Seal Cond: **Unknown**
